# SINGLE SURVEY

Survey report on:

<b>Surveyor Reference</b>	WH/2140/DD
<b>Customer</b>	Aileen Webster
<b>Selling address</b>	Flat 402 95 Morrison Street Glasgow G5 8BS
<b>Date of Inspection</b>	20/09/2024
<b>Prepared by</b>	David Donnachie, BSc MRICS Glasgow South - Allied Surveyors Scotland Ltd

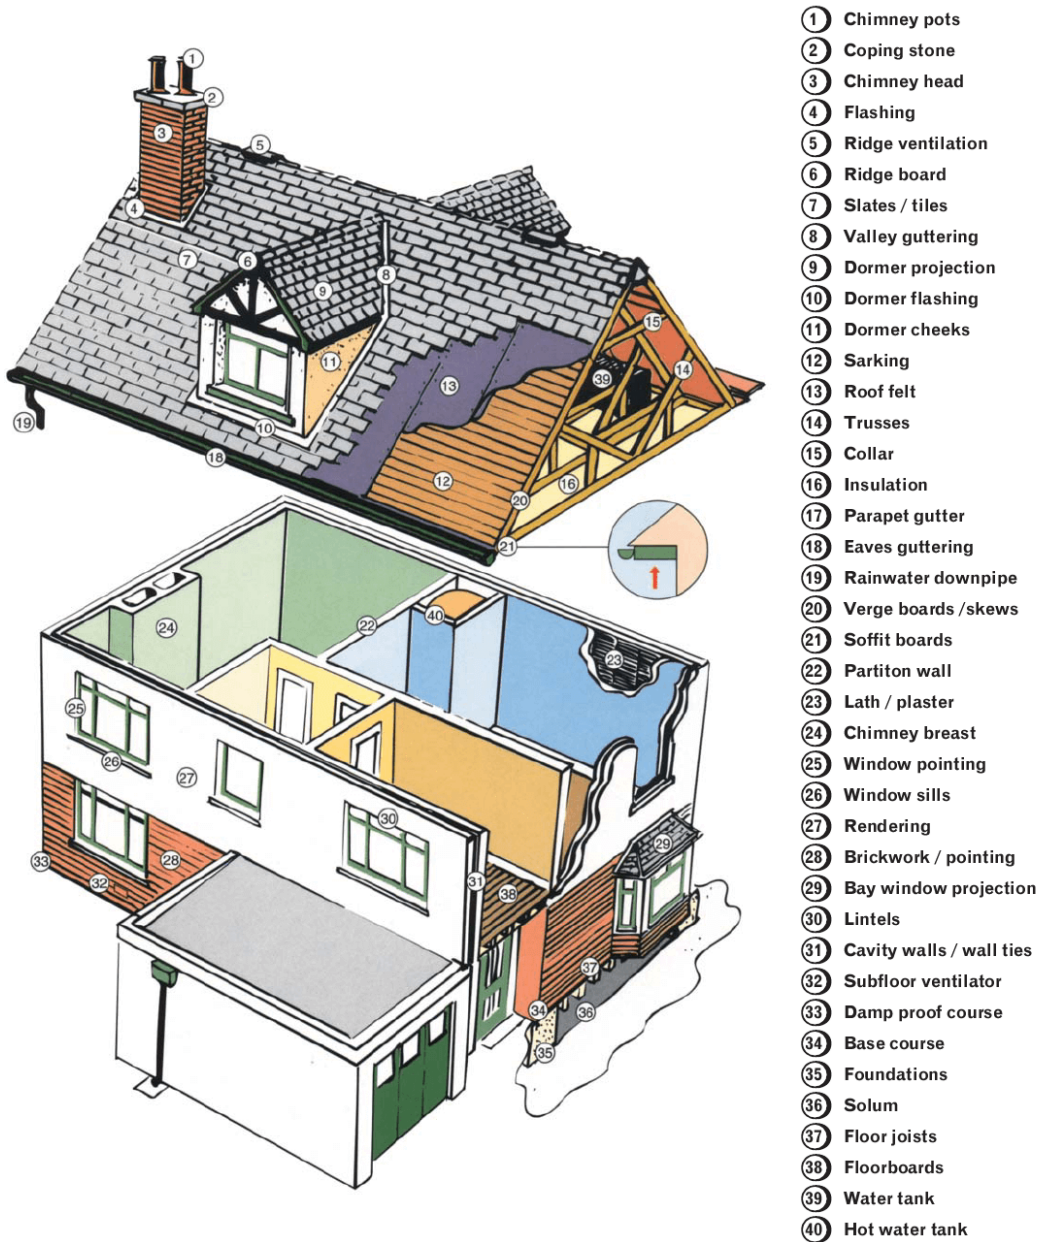
## Sectional Diagram showing elements of a typical house

Reference may be made in this report to some or all of the above component parts of the property. This diagram may assist you in locating and understanding these items.
