Home Report

Single Survey

Property address	Flat 9g Hanover Court North Frederick Path Glasgow G1 2BG
Customer	KAMAL ESTATES
Customer address	Flat 9g Hanover Court North Frederick Path Glasgow G1 2BG
Prepared by	Shepherd Chartered Surveyors
Date of inspection	17/09/2024

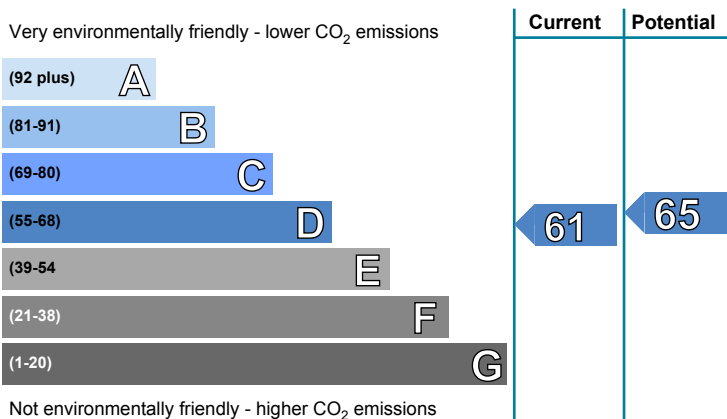
Environmental Impact (CO₂) Rating

This graph shows the effect of your home on the environment in terms of carbon dioxide (CO₂) emissions. The higher the rating, the less impact it has on the environment.
