# Home Report

# Scottish Single Survey

<b>Property address</b>	131 Blairbeth Road Rutherglen Glasgow G73 5BU
-------------------------	--------------------------------------------------------

<b>Date of inspection</b>	04/10/2024
---------------------------	------------

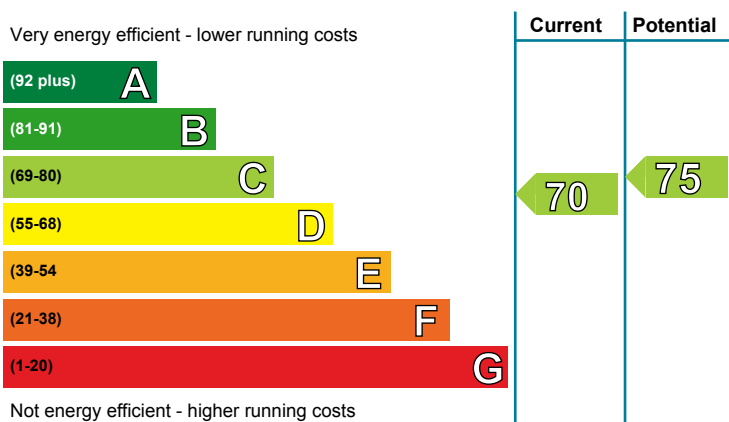
## Energy Efficiency Rating

This graph shows the current efficiency of your home, taking into account both energy efficiency and fuel costs. The higher this rating, the lower your fuel bills are likely to be.

Your current rating is **band C (70)**. The average rating for EPCs in Scotland is **band D (61)**.

The potential rating shows the effect of undertaking all of the improvement measures listed within your recommendations report.

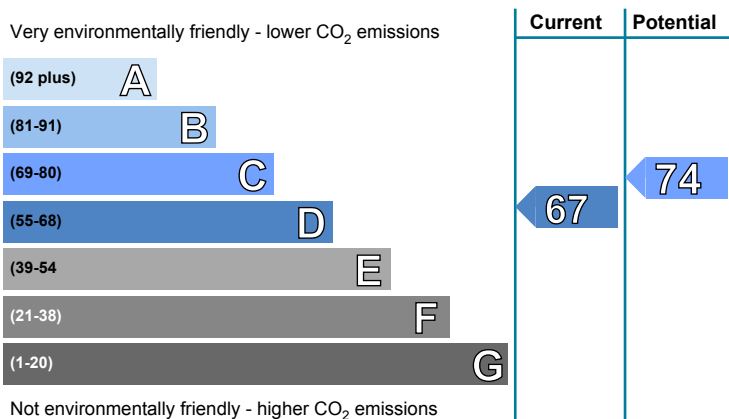
## Environmental Impact (CO<sub>2</sub>) Rating

This graph shows the effect of your home on the environment in terms of carbon dioxide (CO<sub>2</sub>) emissions. The higher the rating, the less impact it has on the environment.
